Single-Tooth Replacement on an Existing Tooth: Procera Crown Alumina

Shahriar Parvizpour, DDS

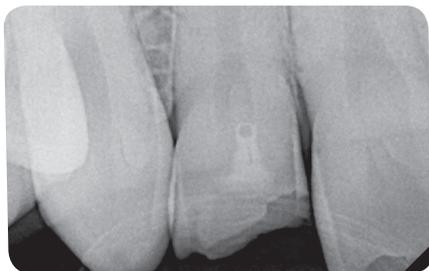
A preoperative radiograph (Figure 1) revealed a major fracture to tooth No. 7, with no peri-apical pathology or changes to the alveolus. A pulp test was normal, and there appeared to be no periodontal concerns. The patient was healthy, with no medical concerns or contraindications for dental treatment.

Figure 1 Preoperative radiograph showing fractured tooth No. 7.

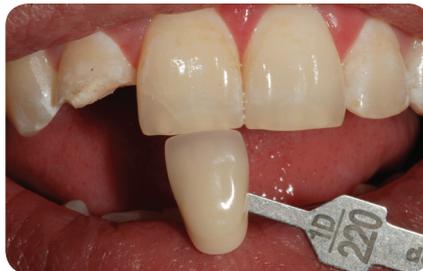
Before preparation of the tooth, a shade match was taken (Figure 2). Drilling may cause dehydration of the adjoining teeth and subsequent problems with achieving an accurate match, therefore the shade should be taken prior to work.

Figure 2 Before tooth preparation, a shade tab was used to take a match.

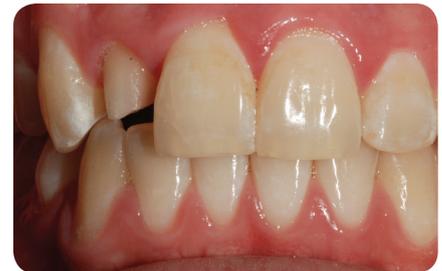
Figure 3 Several weeks after tooth preparation, the patient returns for the crown.

Several weeks after tooth preparation, when the tissues were healed, the patient returned for delivery of the final restoration (Figure 3 and Figure 4). A NobelProcera alumina crown was placed and cemented using resin-modified glass ionomer cement. The final results satisfied the patient's requirements (Figure 5 through Figure 7).
